Listed Building  
Guidance Leaflet

Shop  
Fronts

English  
Heritage

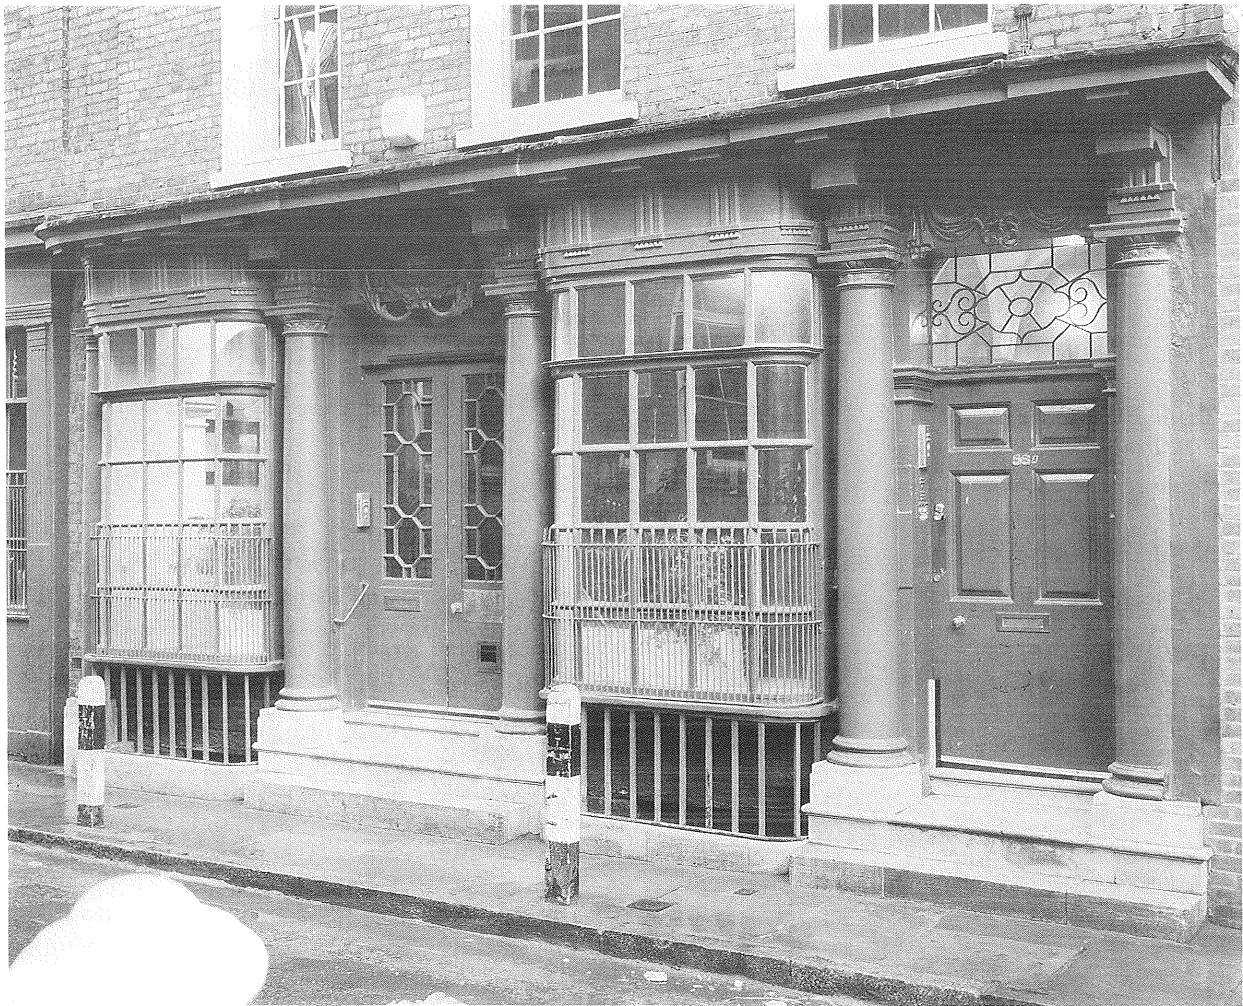
*56 Artillery Lane, Spitalfields, London (1756-7)*

Surviving examples such as the magnificent front at 56, Artillery Lane Spitalfields (1756-7) show that in the mid-eighteenth century the glazing divisions were small and the stall riser quite high. The wide glazing bars projected only slightly in front of the glass. Comparison with another well-

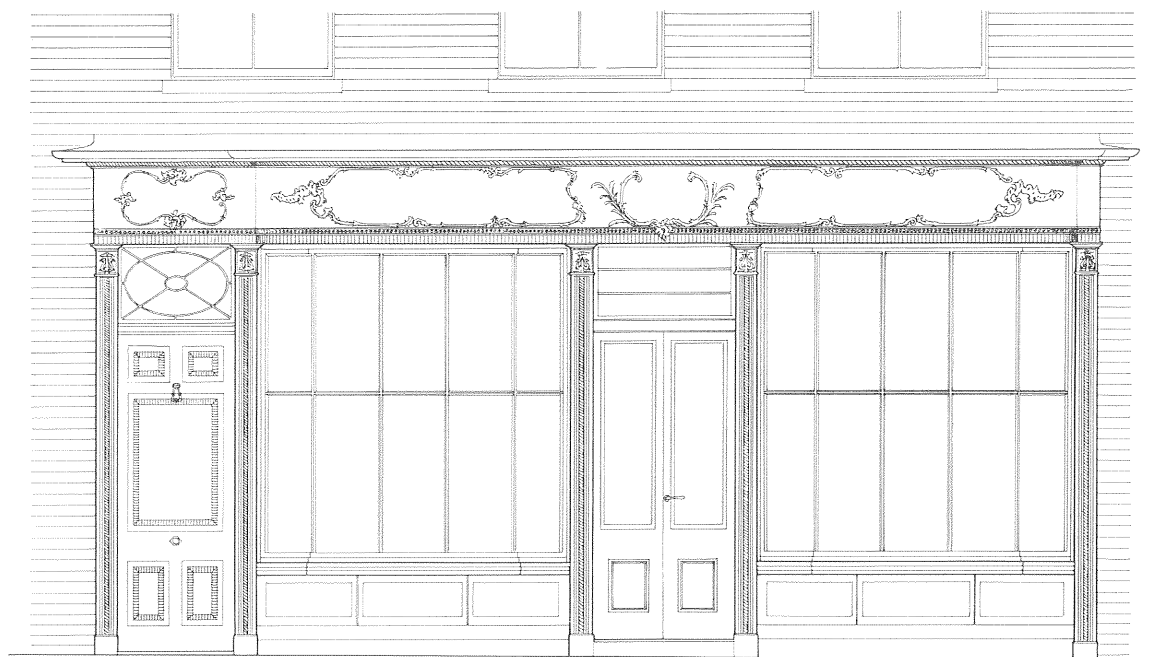
*A late eighteenth-century shop  
front*

*A shop front of the late eighteenth century. The shop door appears to be a  
later nineteenth-century insertion. Dean Street, London*

preserved shop front of almost forty years later, at 88, Dean Street, Soho, shows how each component had been refined; fewer glazing divisions, thinner glazing bars, and a lower stall riser, the whole composition framed by delicate pilaster strips.

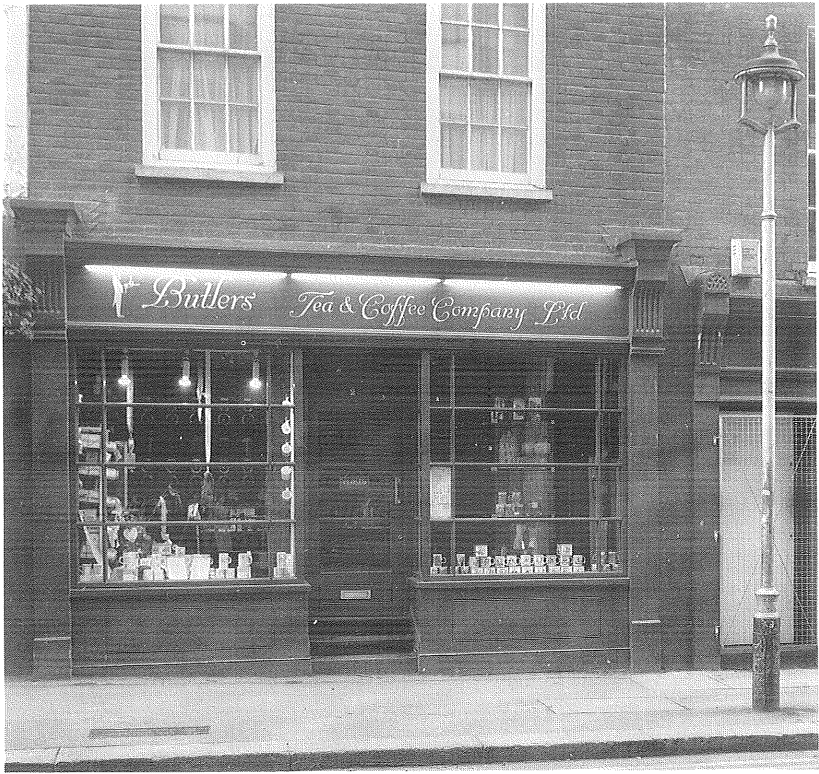
An example of a new shop front sympathetically designed in keeping with the date and scale of the original building

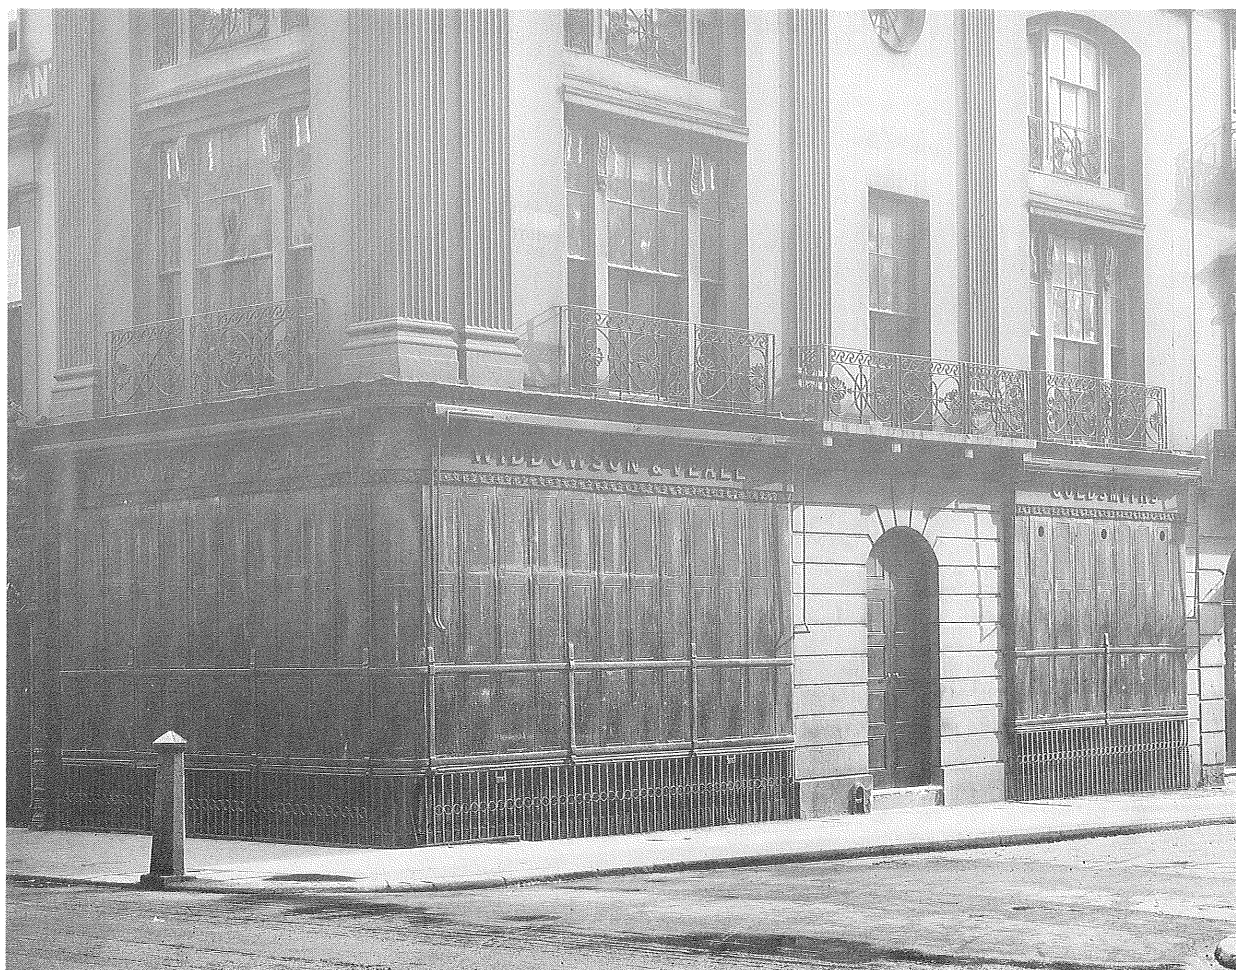
*An example of traditional shop front shutters*

Before the 1830s shop windows were closed at night with wooden shutters, held in slots within the stall board and the soffit of the fascia, and secured with iron bars. Such a system can still work perfectly well if shopkeepers are willing to take down and put up the shutters every day.

In the mid-nineteenth century wooden shutters were superseded by revolving iron shutters, housed in a box in the entablature and lowered in iron grooves. Many examples of this system still work well today.

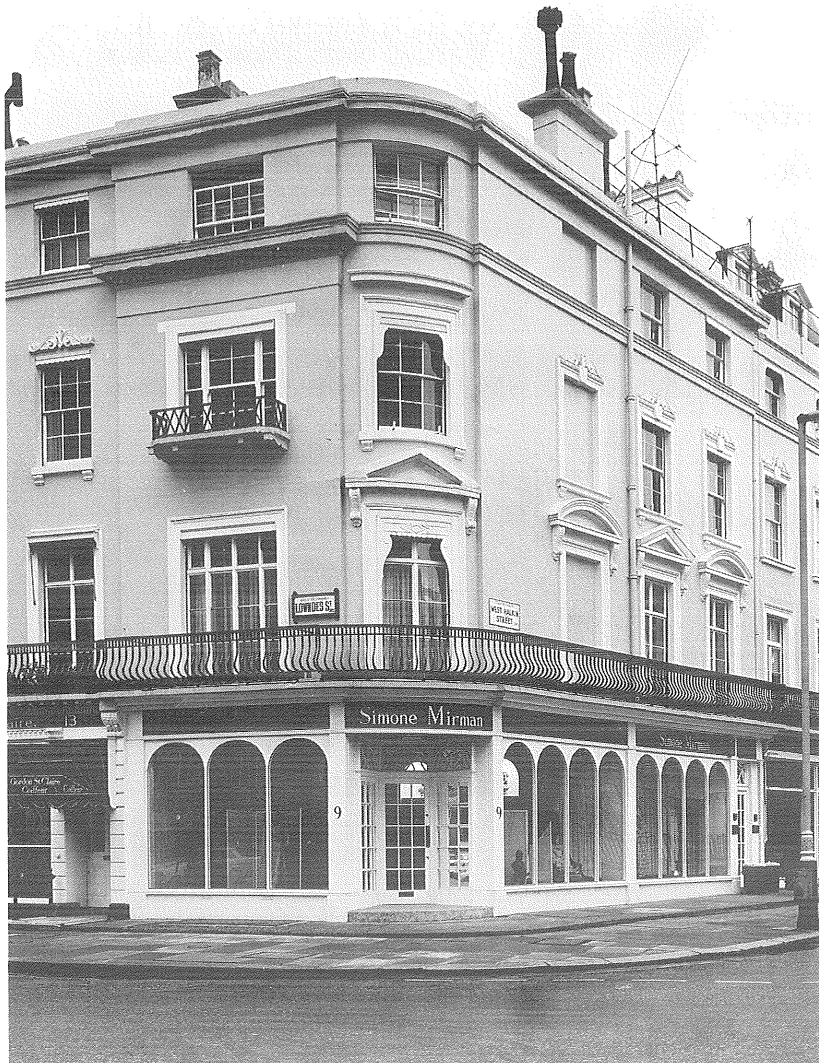
*An example of a sympathetically designed twentieth-century shop front which replaced unsuitable plate glass windows*
