Scaffolding and temporary works for historic buildings

ENGLISH HERITAGE

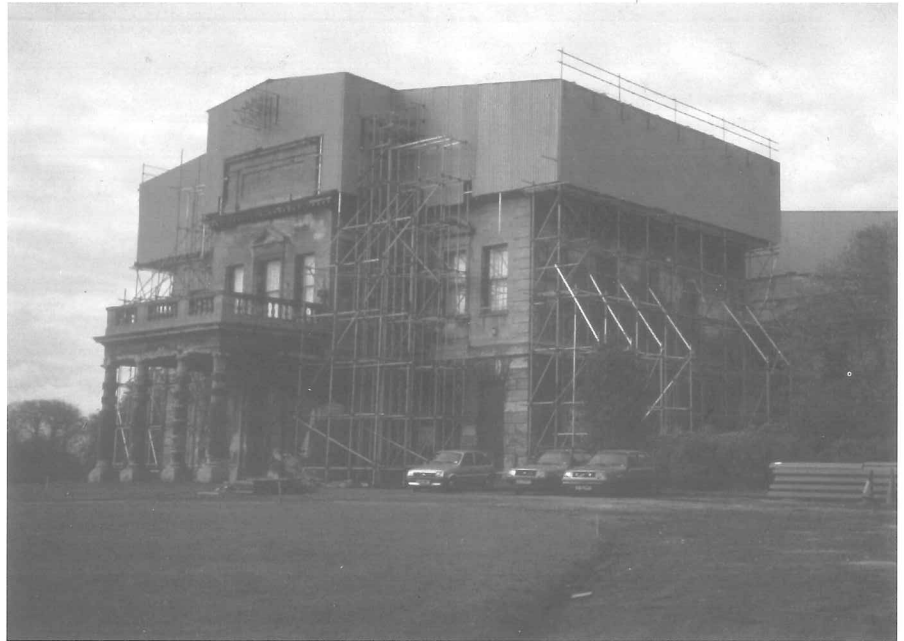
Scaffolding as complex as this must be properly designed

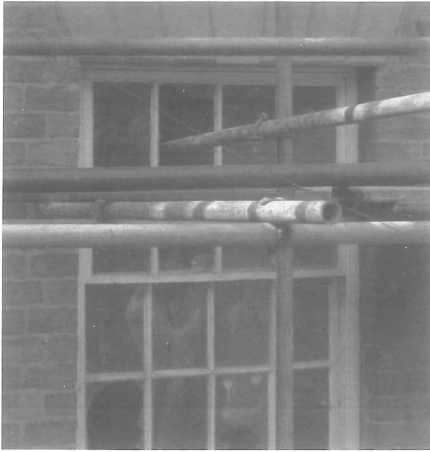
Opening the window would have avoided smashing old glass

Through ties are simple to use with sash windows. The sash can be raised to allow the tube to pass through, the resulting gap sealed temporarily with plastic sheeting or hardboard, and the sashes screwed to each other to prevent unauthorised entry. Casement windows are more difficult. If they carry leaded lights it may be possible to remove one small pane but casements with a single glazed sheet may need to be taken off their hinges and stored safely. Regrettably, some scaffolders just smash a window to get their fixings. This is particularly likely in a derelict building.

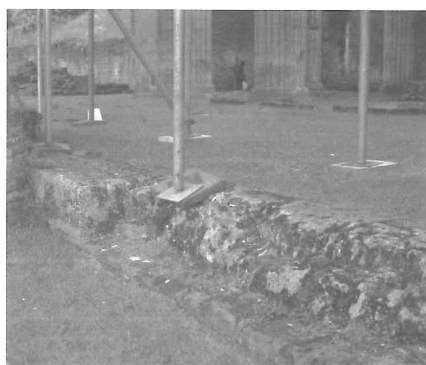
All scaffolding must be properly founded

The soil should be well rammed to ensure that there are no cavities and timber sole plates at least 230mm x 40mm should be used. Where the ground is not firm or where the length of time that the scaffolding is to remain erected exceeds six months, railway sleepers or similar sized timbers are more suitable. Foundations should always be level and should never be undermined. The foundation and the standard or prop set on it should be concentric to avoid inducing bending moments or eccentric forces.

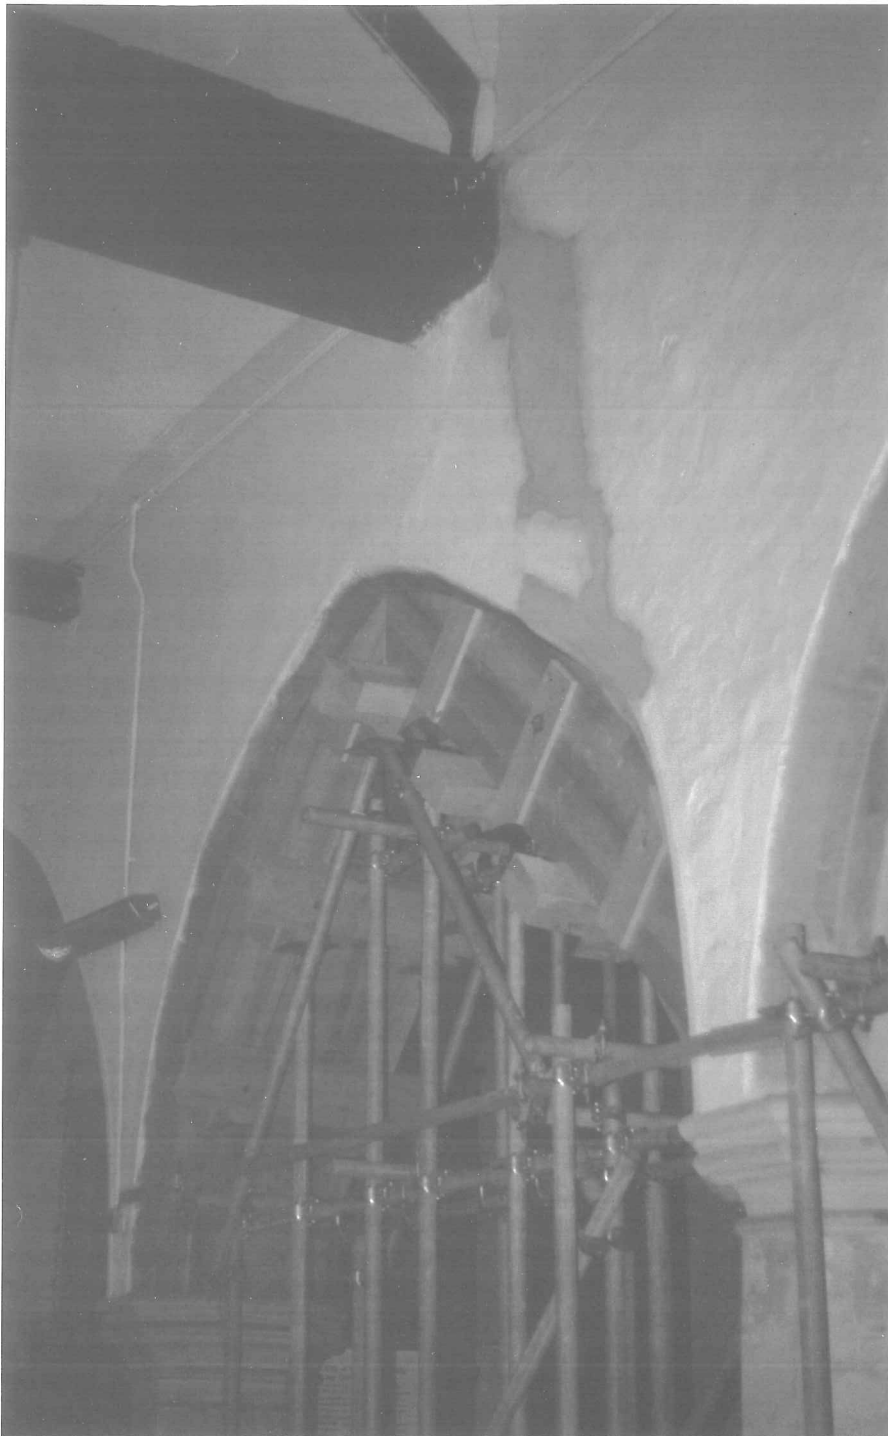
A well designed temporary support

Shoring must be designed by a competent person and account must be taken of wind, dead and superimposed loads, slenderness ratio of members, slenderness ratio of structure, bracing, foundations, fixing to permanent structure, permissible stresses of materials, safety factors, and any other relevant considerations. The main difficulty with shoring historic buildings is to ensure that temporary works do not cause damage in the process of being installed.

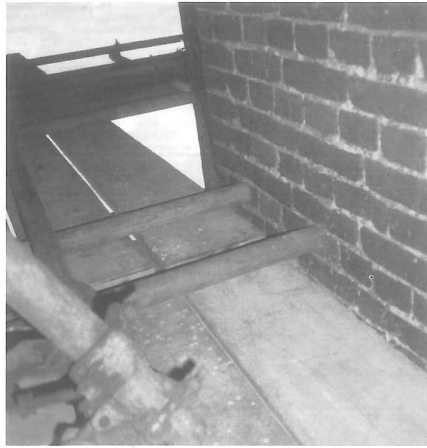
All tubes within 25mm of a wall must have plastic caps

Scaffolding, however well constructed, is always likely to move slightly and a tube end rubbing on a wall face can easily cause permanent scarring. All tube ends that either touch a wall or are within 25mm of it should have plastic end caps. All other points of contact or near contact between scaffolding and historic buildings should be protected in some way. All standards should sit on timber sole plates to spread the load and floors beneath should be protected with polythene sheet, old carpet, or similar materials to prevent damage.
